THEA FOSS AND WHEELER-OSGOOD WATERWAYS REMEDIATION PROJECT

YEAR 12 MONITORING

HABITAT MITIGATION AREA AND SLOPE REHABILITATION AREA PRELIMINARY FINDINGS MEMORANDUM

AUGUST 23, 2018

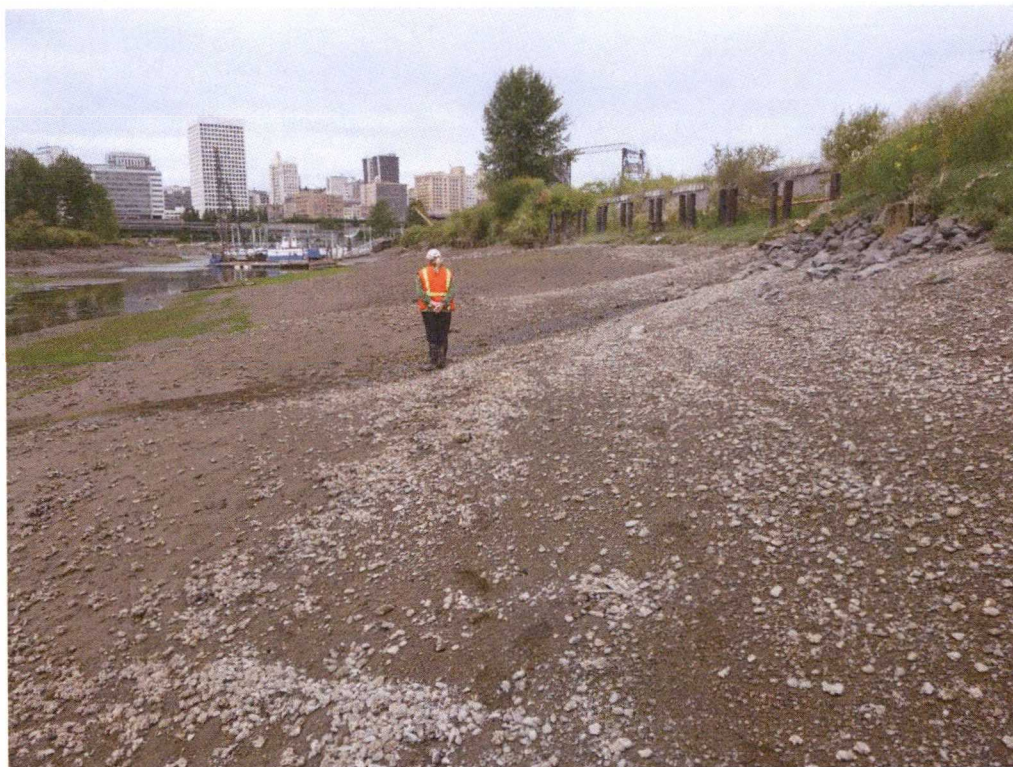
Year 12_RA-10_P1020468

Photograph Number	Latitude/Longitude (Northing/Easting)	Direction of Photo	Time	^{Actual} Tide Level (MLLW)	Notes
102-0468	705338, 1161669	W	1224	-1.3	Beginning of interval looking west.
469	705361, 1161622	NW	1225	-1.3	South of rusty pipe looking NW
470	705389, 1161566	NW	1227	-1.3	" " 2nd " " " NW
471	" "	W	1227	-1.3	" " " " " W
472	705404, 1161503	W	1228	-1.2	South of end of concrete wall.
473	705433, 1161430	W	1230	-1.2	15' SE of outfall pipe.
474	705457, 1161341	W	1231	-1.2	South of large tree.
475	705471, 1161285	W	1234	-1.1	South of start of concrete on pilings.
476	705506, 1161237	W	1236	-1.1	20' east of concrete block.
477	705513, 1161206	W	1237	-1.1	from top of concrete block.
478	705520, 1161163	W	1239	-1.1	5' east of outfall pipe.
479	705543, 1161089	W	1241	-1.0	From old log. ~350' from end of interval
480	705566, 1161005	W	1242	-1.0	25' east of ramp.
481	705567, 1160964	W	1243	-1.0	Under ramp.
